Manhole Inspection Summary

Manhole # S09II1010MH

Insp Date: **1/12/09 2:09 PM**

Location Address: **4600 WABASH AVE**

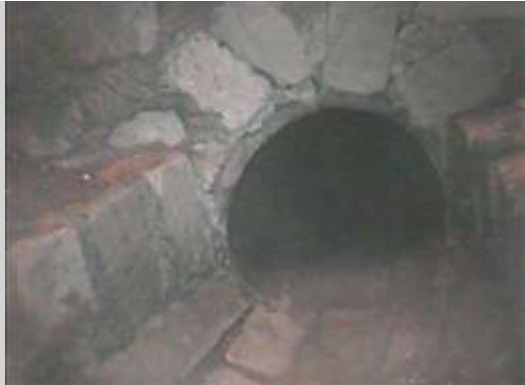
12 O'Clock Outflow

8 in. Circular Gravity Sewer
Pipe Out @ 12 O'Clock

Pipe Height: (in.) Direct
Pipe Material: **Clay** ☐ Pipe Lined
Invert Depth: **9.52** (ft.) Flow Characteristics: **Slow**
Deposits: ☒ None ☐ Mud ☐ ~~Gravy~~ ☐ Debris ☐ Grease
Silt Depth: (in.) Deposits Extent:
Infiltration: **None** Pipe Seal Cond: **Sound**

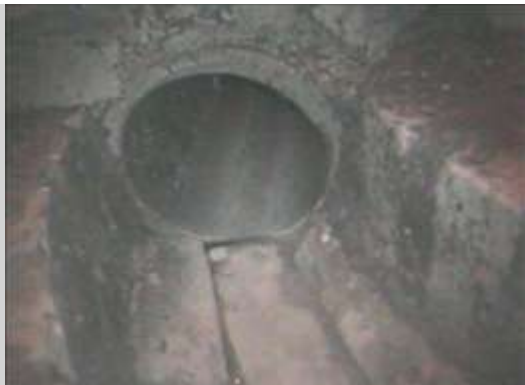
7 O'Clock Inflow

6 in. Circular Gravity Sewer
Pipe In @ 7 O'Clock

Pipe Height: (in.) Direct
Pipe Material: **Clay** ☐ Pipe Lined
Invert Depth: **9.28** (ft.) Flow Characteristics: **Slow**
Deposits: ☒ None ☐ Mud ☐ ~~Gravy~~ ☐ Debris ☐ Grease
Silt Depth: (in.) Deposits Extent:
Infiltration: **None** Pipe Seal Cond: **Sound**
